Jul 18th, 2024

Home Inspection Report

Malcolm Melancon / Hidden Gem Real Estate Inspections, PLLC

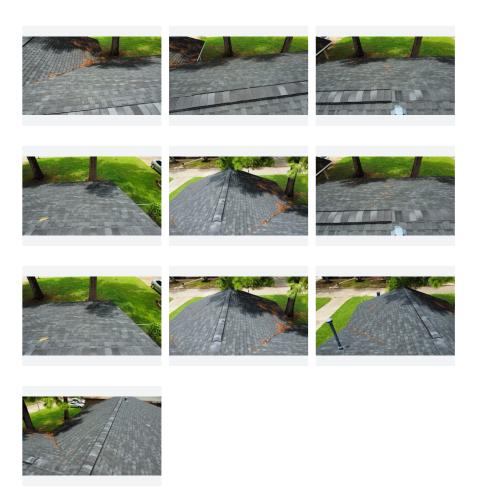
Location: Roof

Information: The roof covering materials were observed as an architectural style asphalt shingle on top of a wood slat deck. The architectural style asphalt shingle is a 30 year shingle.

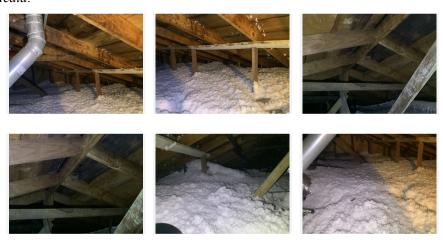
Location: Attic

Information: The roof structure was observed as 2 x 6 rafters and 2 x 6 joists and purlin braces and collar

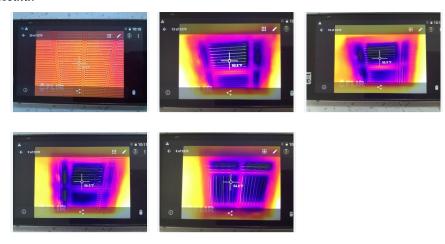
Information: The differential temperature was taken between the supply and return registers for the central AC system with an infrared camera. The differential temperature for a central AC system according to the Texas standards is between 14 and 22°. The differential temperature recorded between the supply return registers was observed In between 14 and 22°
